YANKEE LAKE DAM
SULLIVAN COUNTY, NEW YORK
INVENTORY No. NY 332

PHASE I INSPECTION REPORT NATIONAL DAM SAFETY PROGRAM

PHASE 1 INSPECTION REPORT
NATIONAL DAM SAFETY PROGRAM
YANKEE LAKE DAM I.D. No. NY 332
DEC #163D-168 DELAWARE RIVER BASIN
SULLIVAN COUNTY

Name of Dam: Yankee Lake Dam (I.D. No. NY 332)
State Located: New York
County Located: Sullivan
Stream: Pine Kill (a tributary of the
Basher Kill and Neversink River)
Dates of Inspection: October 20 and 24, 1978

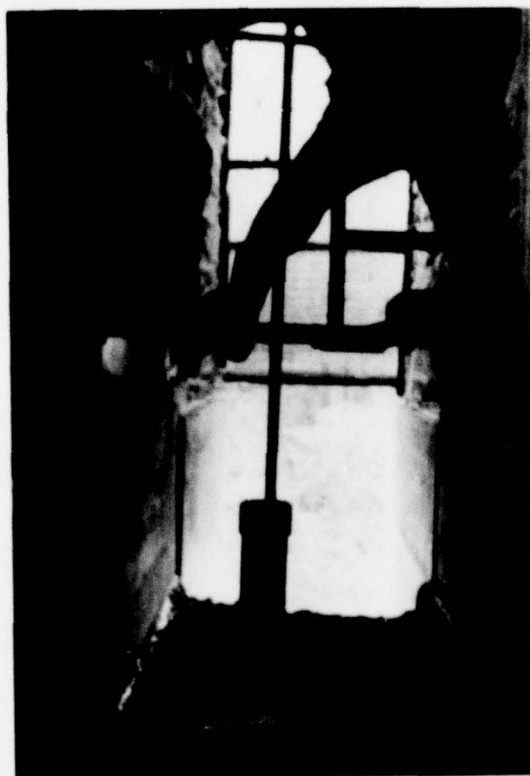
Photograph #10

Spillway channel viewed from inside dam looking downstream
Note: New concrete walls and stoplogs on platform
